Downriver Marine Surveyors

VESSEL INFORMATION

Manufacturer: Sea Ray Boats

Model number or name: 370 Express cruiser

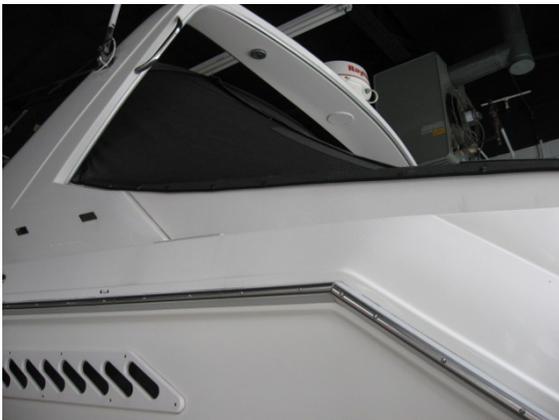
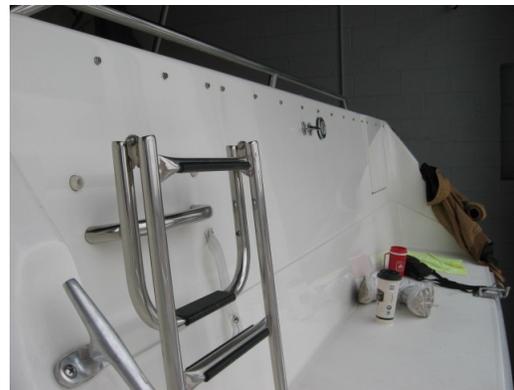
Forward deck: Cored fiberglass reinforced plastic w/non slip pattern. The forward deck around the windlass indicated moist but sounded solid. All other areas of the forward deck indicated dry and sounded solid.

Side decks: Cored fiberglass reinforced plastic w/non slip pattern. The starboard side deck indicated wet and returned a hollow sound around the #6 bow rail stanchion. All other areas of the starboard deck indicated dry and sounded solid.

The port side deck from the shore power inlet aft the entire length indicated moist to wet and sounded solid. The port side deck indicated wet but sounded solid around the spring cleat.

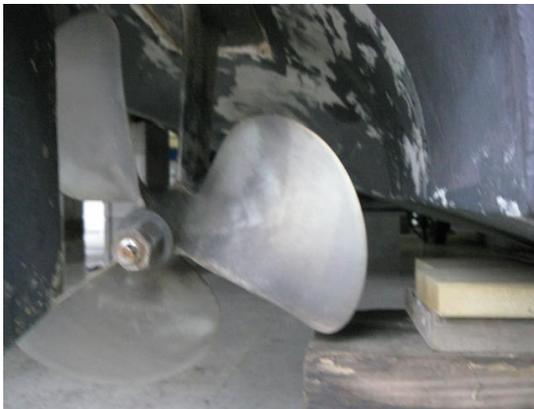
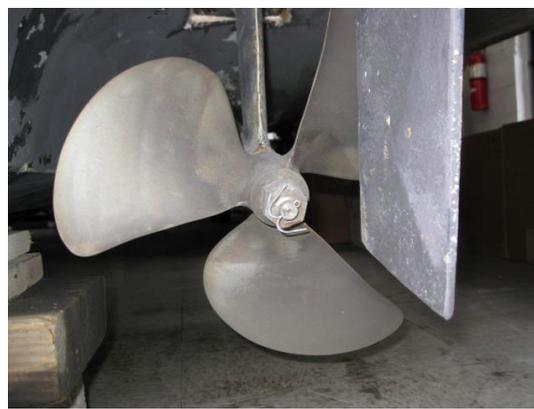
The propellers showed no damage.

The port cutlass bearing showed slight cracking.

The cotter pin was missing on the port shaft.

According to the manufacturers' tag the port transmission was built in Italy and the starboard transmission was built in Germany. A local dealer for ZF transmissions was contacted and stated according to the serial numbers the port transmission is approximately 5 to 6 years old and the starboard transmission approximately 13 to 14 years old. There apparently was a problem with the port side running gear that resulted in the port transmission being changed.

Install cotter pin was missing on the port prop shaft.

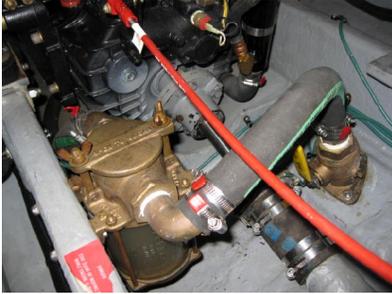
- Port engine cooling water: 1 1/4" flange mounted tapered plug valve
- Starboard engine cooling water: 1 1/4" flange mounted tapered plug valve
- Air conditioner pick up: 1" flange mounted tapered plug valve
- Hull drain: 3/4" NPT plug at bottom center of transom

Remarks: All sea cocks were operable and there was no evidence of cracking on the hose exteriors.
Sea cocks should be maintained on a regular basis to ensure proper operation when needed.
